Assessment of Resource Recovery Centres

About the RRC Assessments

Reincarnate and Randell Environmental Consulting were engaged to assess all council operated RRCs across the region against best practice standards, to identify and prioritise infrastructure improvements.

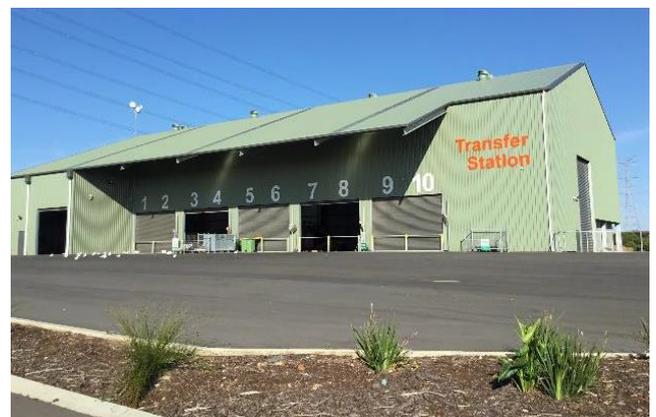
There are several facilities in the region that have well developed infrastructure to support the recovery of materials, have good site amenity and can store materials undercover. These facilities provide a benchmark for other sites in the region.

Best practice facility - Portland Transfer Station

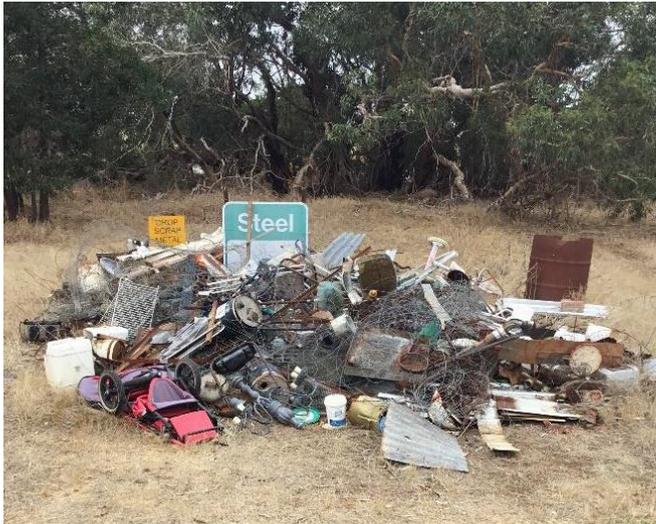
Whilst site management across the region is varied, there are some well managed sites across the region. Even where there is little infrastructure, some sites are well managed as evidenced by no litter and well separated materials.

Steel is stored separately with no contamination at Woorndoo Transfer Station

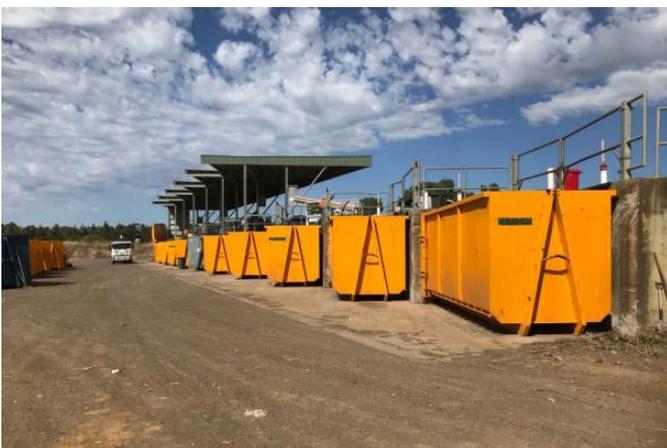
Most facilities have good infrastructure for the collection of residual waste such as engineered platforms and concrete hardstands.

Engineered platforms at Drysdale Transfer Station

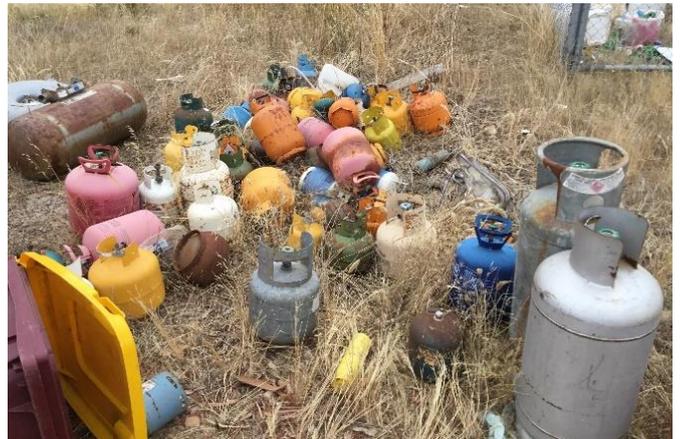
Lack of infrastructure for the collection and storage of recyclable material is the biggest challenge for the region. Materials such as e-waste, batteries, gas bottles and mattresses are commonly stored on the ground with no hardstand or cover. Poor storage of materials can pose risks to human health and the environment through potential leaching of hazardous materials and fire risks.

Gas bottles stored on the ground

1. Shedding for the storage of recycled materials such as batteries, gas bottles and mattresses.
2. Infrastructure for the storage of e-waste that complies with the Waste Management Policy (e-waste). This includes the construction of shedding to store e-waste undercover and on a hardstand.
3. Improved site management including oversight of loads and litter management.
4. Reducing fire risks through appropriate storage of hazardous wastes, reduced stockpiling and managing on-site vegetation.
5. Hard-stand areas, particularly for garden waste.
6. Increased site staffing to improve site management and oversight
7. Improved resource recovery infrastructure and site efficiency at large, high volume sites. For example, transitioning to push-pit infrastructure would allow the additional recovery of material.

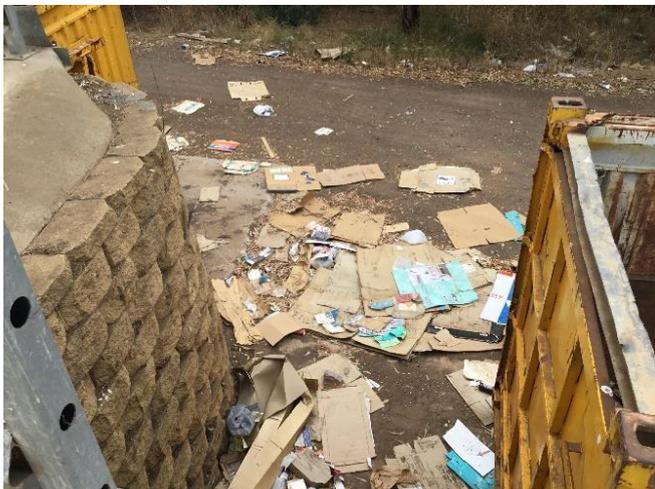
A number of sites assessed had poor amenity, such as litter. This can negatively impact on neighboring land and the community's perception of RRCs. It encourages poor site practices such as illegal dumping.

A contributing factor to litter is poor oversight of incoming loads and disposal areas. For example, often disposal areas are not visible from the gatehouse and site attendants are not able to oversee unloading when the site is busy.

Litter is evident surrounding the skips

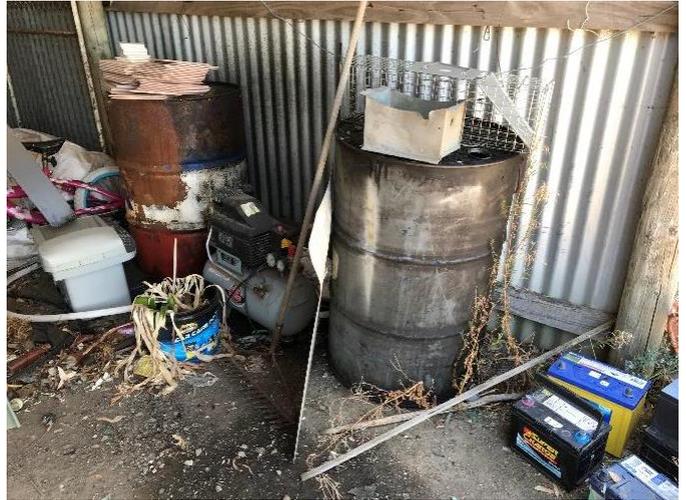
Waste oil is accepted for recycling at 30 of the sites. At many sites, the collection and storage of waste oil does not meet best practice standards. Waste oil units often lacked a bunded hardstand and spill kits. Some sites had evidence of soil leakage onto the ground.

Oil is stored on the ground next to car batteries. There is evidence of oil leakage onto the ground

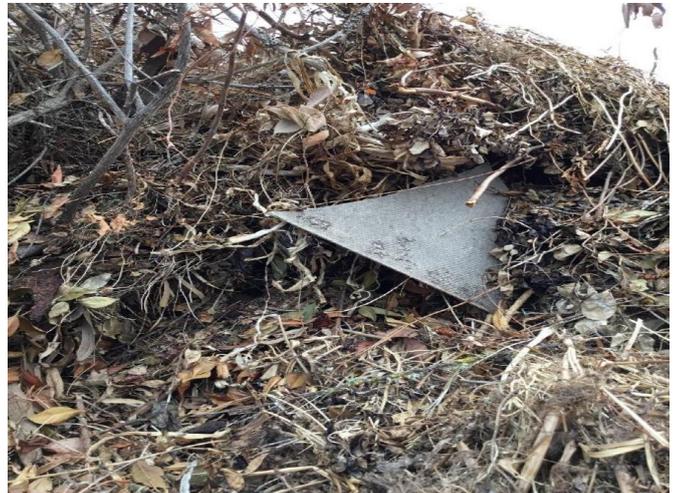
The RRC Assessments identified suspected asbestos materials at three sites. This material is not easily observed when hidden in loads.

The lack of disposal options in the region is likely to be a contributing factor. This should be considered in regional infrastructure planning.

Suspected asbestos material hidden in green waste

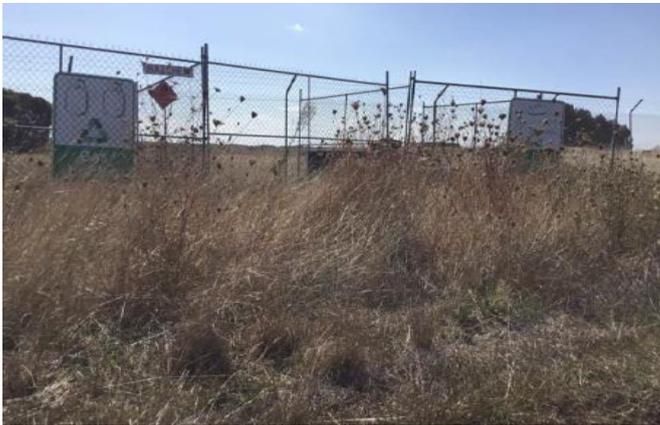
Several sites had fire risks associated with stockpiling of green waste and timber close to treed areas and long grass. These risks are compounded when potential ignition sources such as batteries are stored in the open.

Long grass presents a fire risk

Stockpiled waste poses a potential fire risk and needs to be managed in accordance with the EPA's [Management and Storage of Combustible Recyclable and Waste Materials](#).

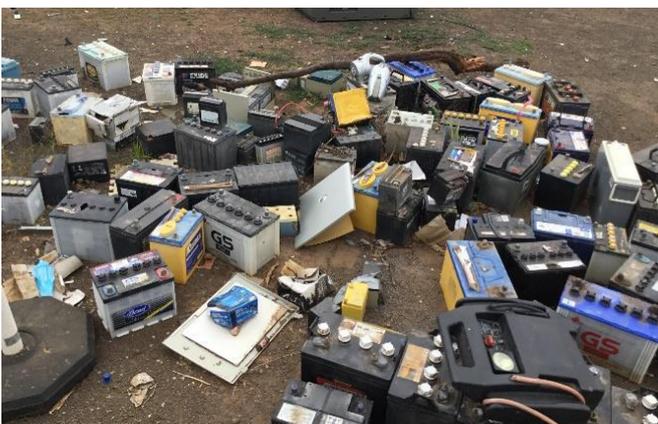
At some sites, particularly at smaller remote RRC facilities, the management of hazardous materials such as batteries and gas bottles pose a risk to human health and the environment. For example, often materials are stored loose, on the ground and uncovered.

Car batteries stored loose on the ground

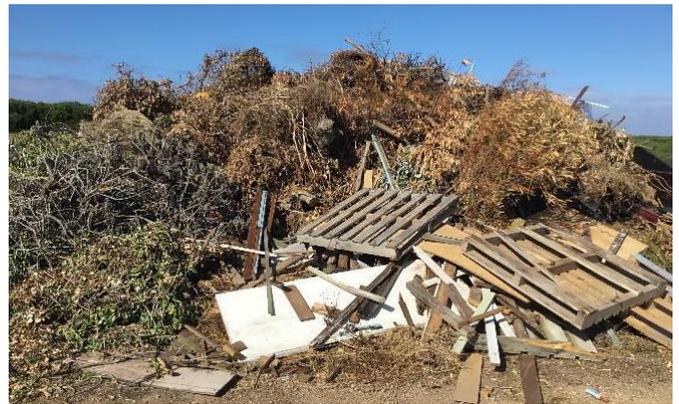
Green waste is the most commonly stockpiled material at RRCs. Stockpiling of unprocessed green waste occurs due to infrequent onsite shredding. Some sites had stockpiles of processed green waste which had no market.

Issues observed with the green waste stockpiles included no stormwater management, no hardstands, fire risks, and contamination.

Treated timber in green waste stockpiles

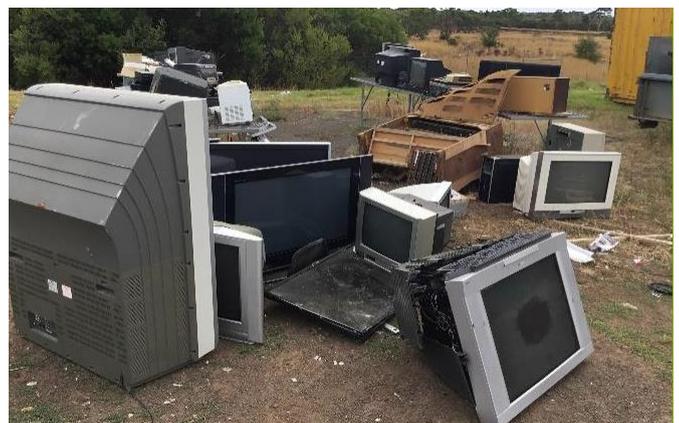
Only six sites complied with the storage and collection requirements specified in the Waste Management Policy (e-waste). Common issues included storage of e-waste on the ground and uncovered, in skips where breakages are likely and combined with scrap metal piles.

E-waste stored loose on the ground

Since the RRC Assessments were undertaken, 10 sites have received funding to construct e-waste shedding that complies with the policy.
